A Field Study of the Performance of EPDM Roofing at Air Force Facilities

Prepared for:
U.S. Air Force
Air Force Engineering and Services Center
Tyndall Air Force Base
Tyndall, FL 32403

Walter J. Rossiter, Jr.
James F. Seiler, Jr.
William P. Spencer
Paul E. Stutzman

January 1991

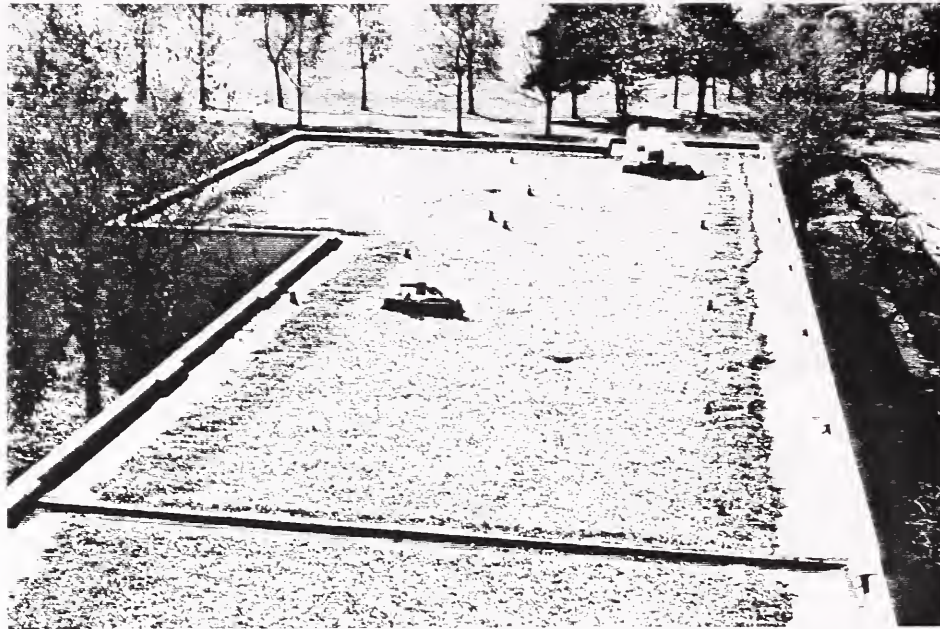
Figure 10. Roof with ballast swept back from the perimeter to allow ready inspection of the base flashing

At one installation, the perimeter base flashings of a ballasted membrane system were uncured neoprene-based rubber. This flashing material had cracked extensively and randomly over the entire perimeter area during the 7 years the roof had been in place. The problem was so extensive that the ballast had been swept back from the building perimeter to have all flashing areas visible for frequent inspection (Figure 10). Many of the cracks had been patched, although some were open to water penetration into the building. The cracks were limited in length, normally a few inches (centimeters) (Figure 11). They occurred at the edge of a wooden cant strip, where the flashing was stretched tight. Apparently, this produced excessive stress in the rubber at that location, which resulted in the cracks.

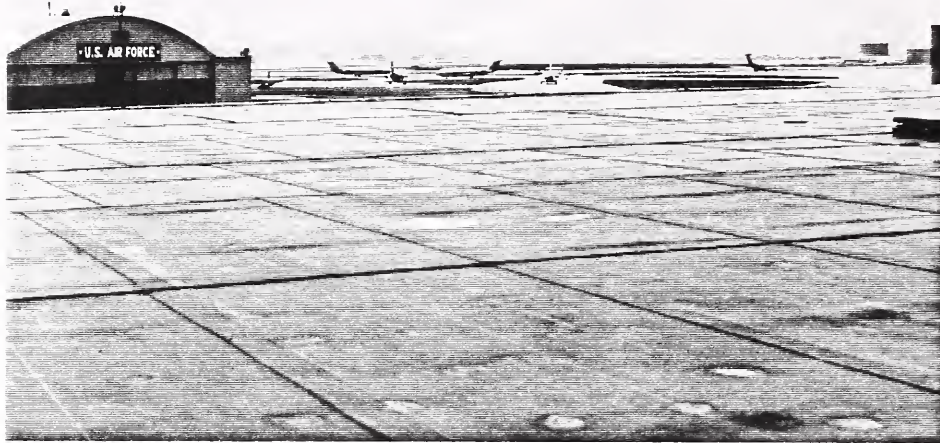
The results of the inspections of the adhered systems were positive, with no visual indications that membrane securement was inadequate. Figure 12 shows an adhered membrane system, typical of those inspected during the survey. The membranes generally appeared tight on the substrates with no evidence of loose areas. In the few cases where seam samples of adhered membranes were taken, the rubber sheets were seen to be well bonded to the substrates. Discussions of the performance of adhered systems with field personnel indicated that securement of the membrane had been satisfactory for most of the roofs. However, two significant anecdotes of wind damage to adhered membranes were reported.

Figure 12. A typical adhered-membrane system

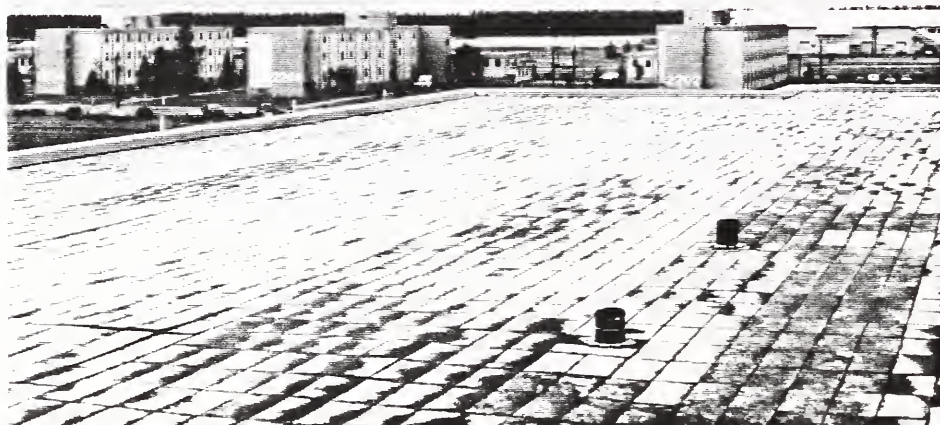
For most of the PMR systems, the base flashings at the perimeters of the buildings were not visible. Figure 19 shows a section of a typical protected membrane roof with concrete pavers used as ballast in Alaska. Note the sheet metal covering obscuring the base flashing at the perimeter of the building.

Figure 19. A typical protected membrane roof with concrete pavers

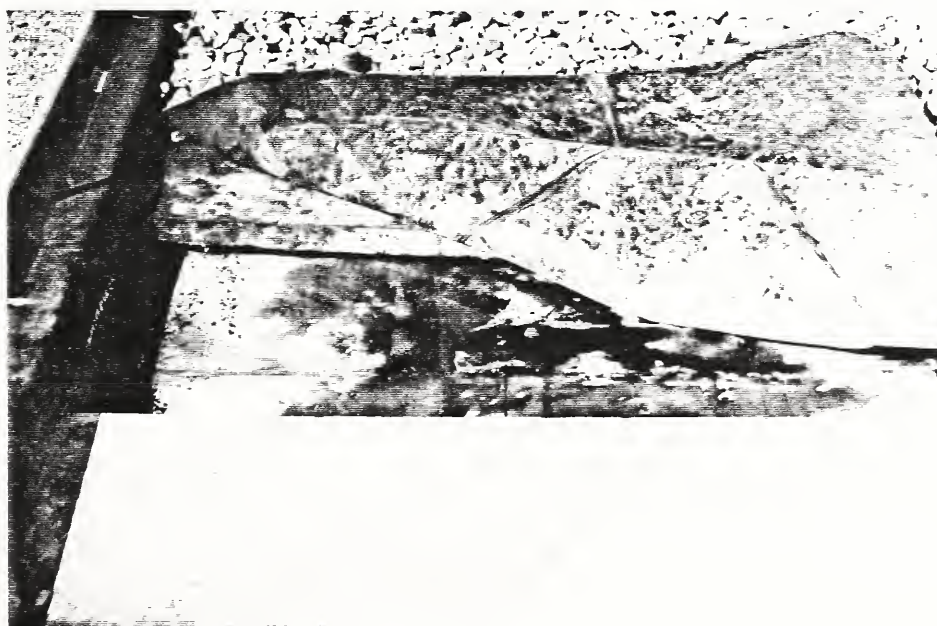
The one PMR roof not in Alaska was located at Pease AF Base. This system was about 7 years old and used gravel as the ballast. Performance was described as being trouble-free. In this case, a "filter fabric" was present under the ballast to keep dirt and debris from washing under the insulation and into the drains. When inspected, no signs of concern were apparent, although the filter fabric had weathered and eroded away in some small areas where it was not covered with ballast. A limited length of a seam was inspected after removing a small section of ballast and insulation boards (Figure 20). As expected, dirt was present on the surface of the membrane. Some areas were damp to the touch, indicating that the seam may experience a relatively moist environment under the insulation boards which can retard drying [20]. As subjectively judged, the limited section of exposed seam appeared to be well bonded and tight, and was without ripples or other signs of distress.

A final note regarding this roof is that the seam exposed for inspection was difficult to locate. It was only found after making some guesses as to where it might be and carefully examining the base flashing at the perimeter of the building for signs that a seam was present. As previously indicated, the search for the seam was another reminder of the importance of having seam locations of ballasted systems marked on roof plans to eliminate needless time spent in finding them.

Figure 20. A seam of a protected membrane roof uncovered during the inspection

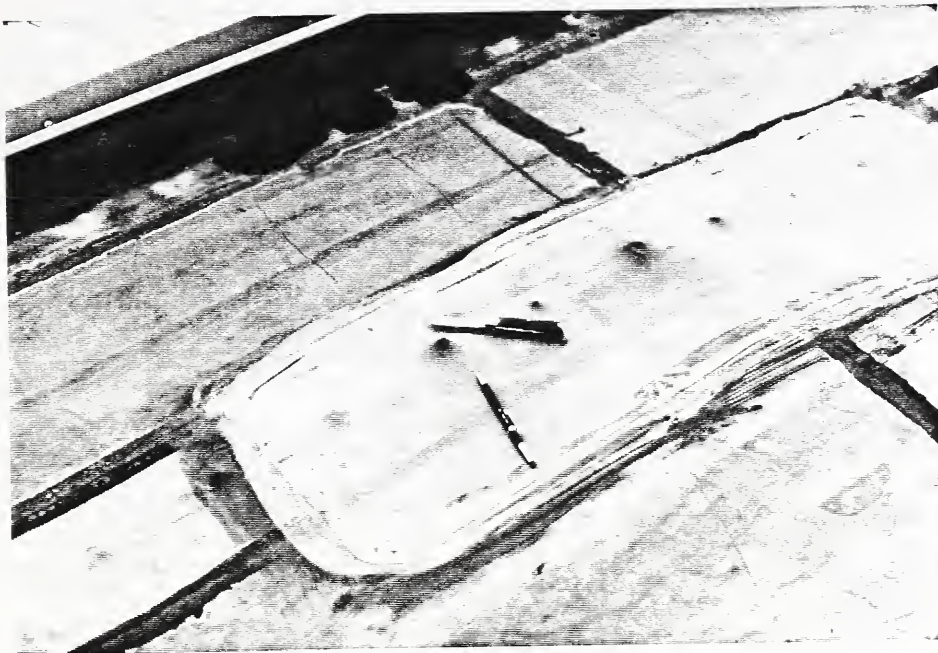
Figure 21. Mechanically-fastened system showing little fastener backout

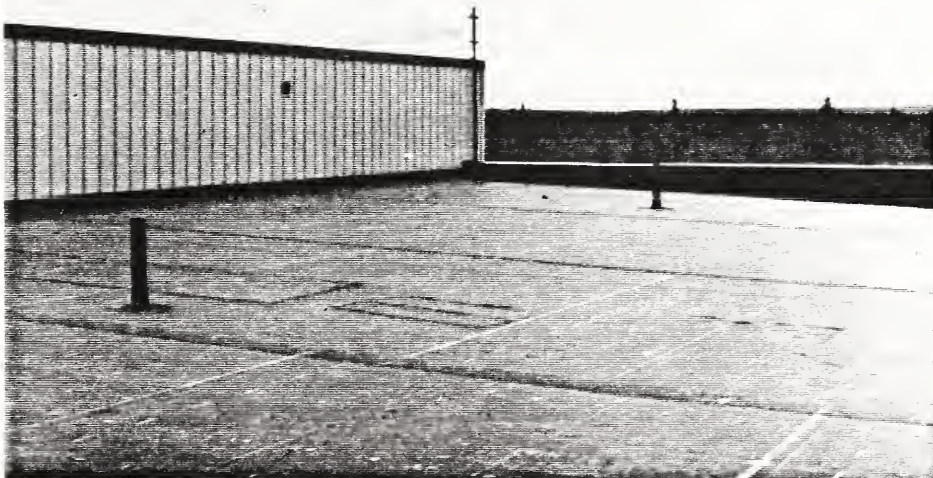
3.4.10 Slope and Drainage. For the majority of the roofs inspected, sufficient slope was observed on the roofs (Figure 28), and the roofs generally drained well. Note in Figure 28 the extent of slope as indicated by the changing height of the parapet wall at the edge of the roof. In addition, where interior drains were observed, they were generally free of debris to provide unrestricted drainage. At one installation, the drain of an exterior gutter was blocked with leaves from an overhead tree. At another facility, an exterior gutter was clogged, but the source of the debris was unknown.

Figure 28. Illustration of the slope incorporated in many of the roofs inspected

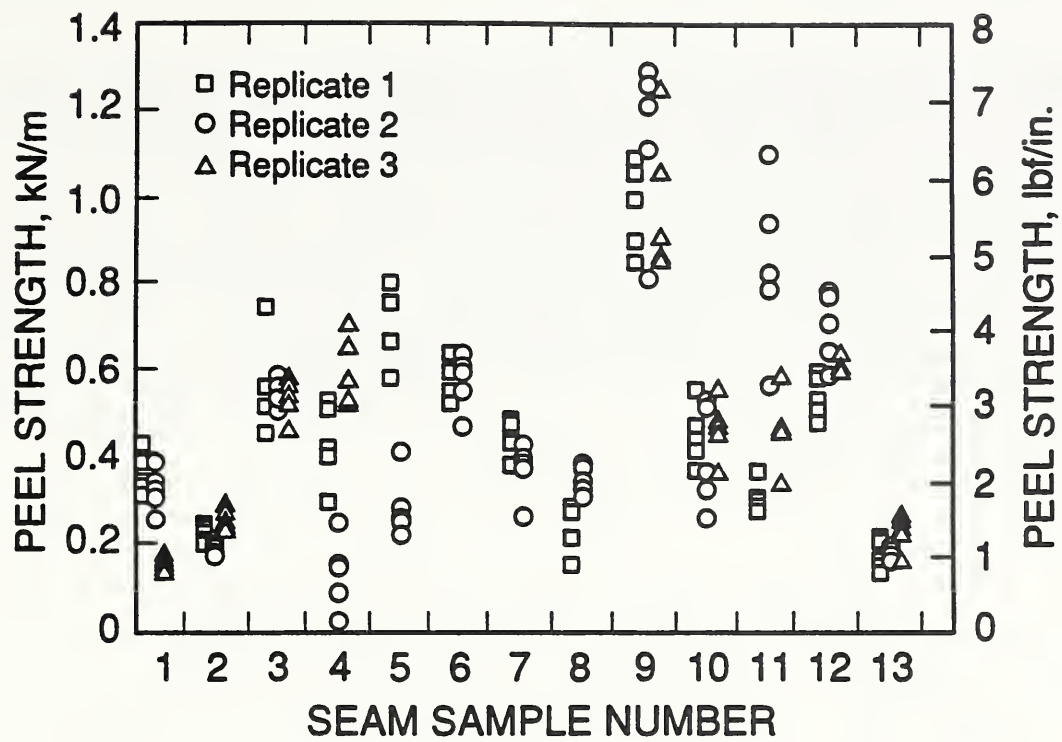
The majority of the adhesives were found to be butyl-based. This was not unexpected considering that butyl-based adhesives came into considerable use in the mid-1980s [26], and the ages of the samples did not exceed 60 months. Two of the adhesive samples (nos. 8 & 13) were neoprene-based. In case of sample no. 4, one of the replicate specimens had an adhesive layer that contained a section of butyl-based adhesive and another of neoprene-based adhesive (Table 6).

Figure 35. Peel strengths of seam samples

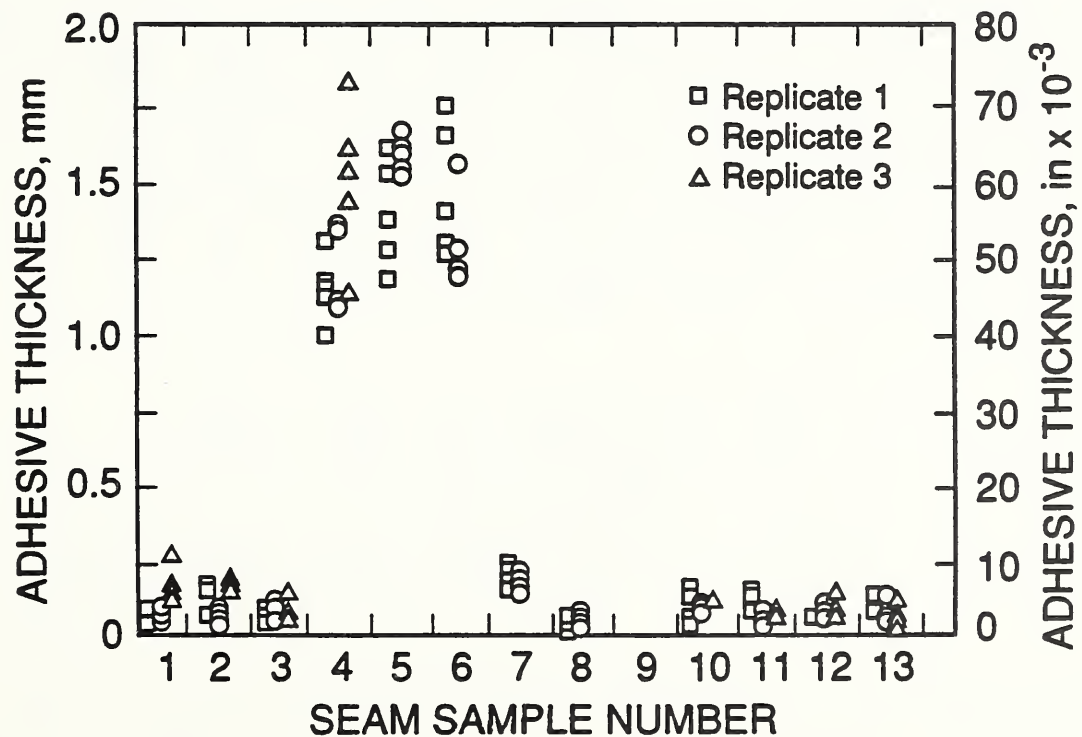
Figure 36. Adhesive thicknesses of seam samples

With the exception of the seam samples from New Boston (nos. 4 - 6), the thicknesses of the adhesive layers were 0.008 in. (0.20 mm) or less (Table 6). These values were comparable to adhesive thicknesses found for other field-prepared seams, and have been considered to be relatively thin [27]. Seams having relatively thin adhesive layers may not be as resistant to peel failure under creep conditions, as they could be if they had thicker adhesive layers [16].

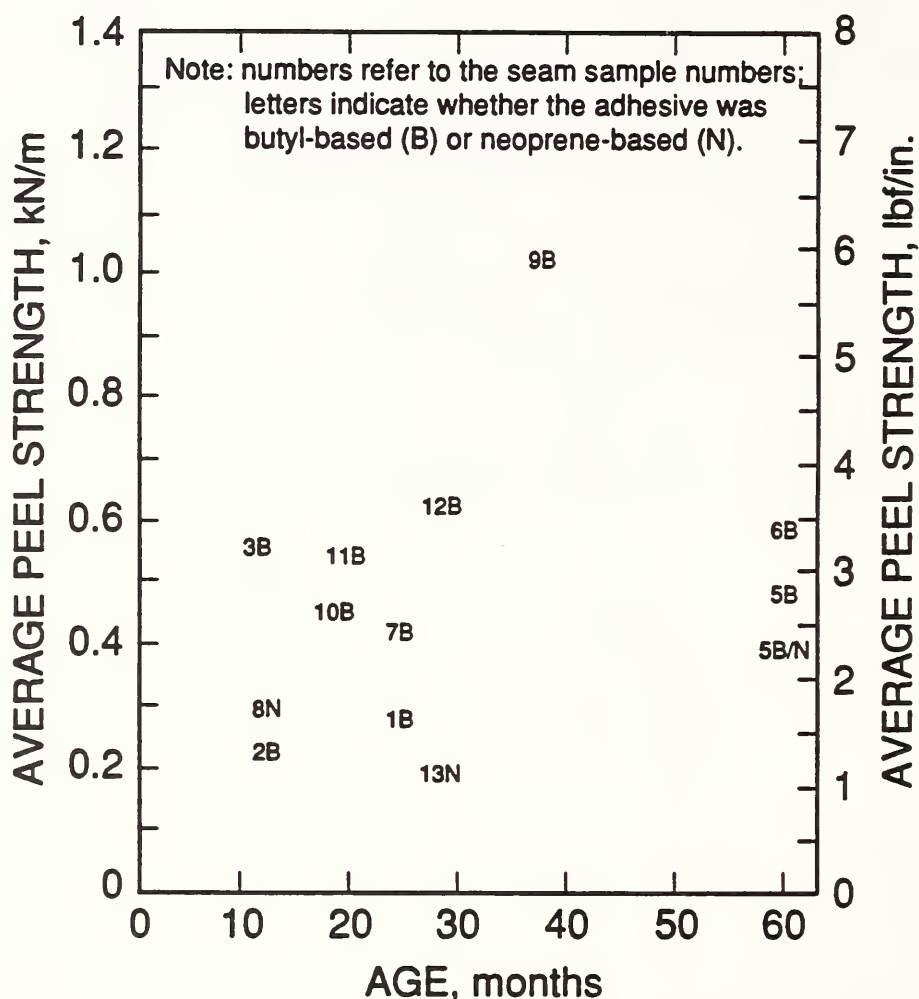
Figure 37 is a plot of peel strength versus sample age. No relation between these two parameters was found. The strengths of the samples ranged from 1.2 to 5.9 lbf/in. (0.21 to 1.0 kN/m). This range of values was comparable to those measured for other field-fabricated seams [27]. Generally, butyl-based seams have strengths greater than neoprene-based seams [28]. In the present study, the strengths of two of the butyl-based samples (nos. 1 & 2) were similar to those of the two neoprene-based seams (nos. 8 & 13).

Figure 37. Average peel strength versus seam sample age
